Thank you for having us on your property to undertake a Dairy Efficient Wa ant of Fitness assessment of your dairy farm effluent infrastructure on 22 June 2015.

Dairy Effluent 'WoF' Certified Assessor

SUMMARY

WOF

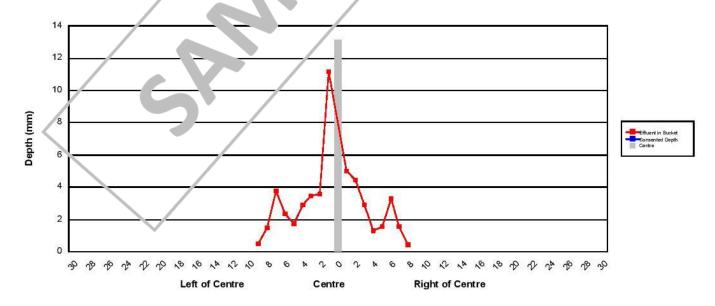
APPLICATION DEPT! TEST FOLL SISPRINKLERS OR CANNONS

Max depth (mm):	11.16
Average depth (mm):	3.02
Average Applicaton Rate (mm/hr):	3.07
